# Driving Safety Support Systems Utilizing ITS Radio System

Yuichi TANIGUCHI\*, Toshifumi OOTA, Masafumi KOBAYASHI, Hirofumi URAYAMA and Yoshiteru KOREEDA

We are striving to develop the Driving Safety Support System (DSSS) that aims to prevent accidents by providing drivers with necessary information for safe driving. We developed a DSSS with infrared (IR) beacons, which has been practically used since July 2011. Now, we have shifted our target to the development of a DSSS with an intelligent transport system (ITS) radio system that can provide sensor data and other dynamic information that is not available with IR beacons. This paper describes the requirements for the DSSS with an ITS radio system, such as communication area and sensor detection area, and presents the result of a verification test.

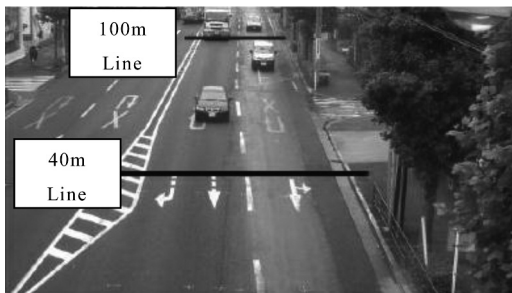
Fig. 6. Sample View from the Upper Stream Camera

Figures 6 and 7 show the test results within the sensor detection area using the image sensors<sup>82</sup>. The sensor detec-

tion area was covered by two image sensors, i.e. cameras, and Fig. 6 shows the upper stream view while Fig. 7 shows lower stream view.

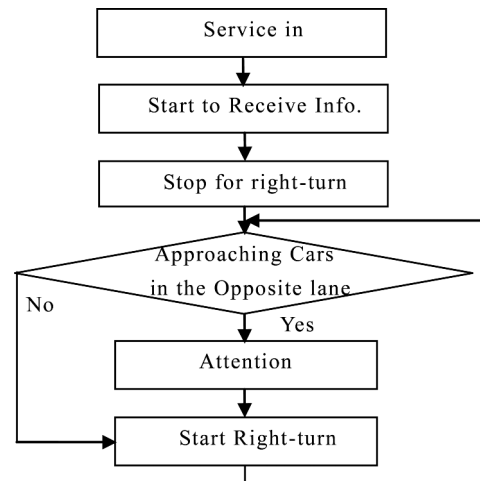
Fig. 8. Sample Service Flow

Figure 8 shows the sample service flow of the Right-Turn Collision Prevention System. The results of our operation verification confirmed that the service was delivered as intended, responding to the operation by the service user driver.
