# Central Tube Cable Ribbon Coupling

**Patrick Van Vickle, Lindsey Alexander, Steve Stokes**

Sumitomo Electric Lightwave

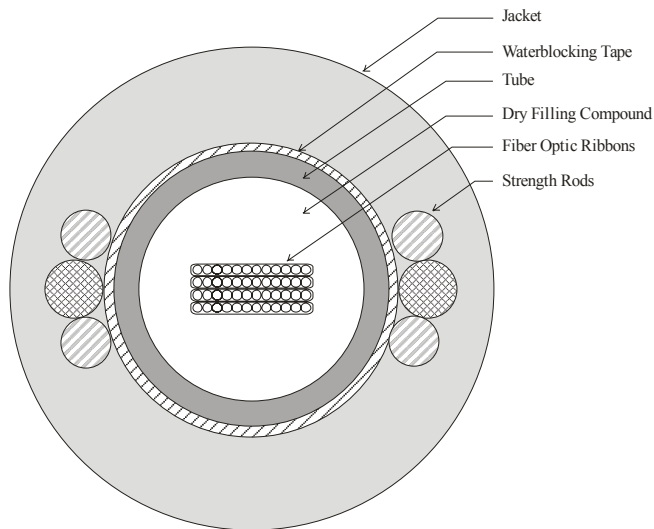
**Figure 1. Dry Central Tube Ribbon Cable Cross Section**

Dry central tube ribbon cables were introduced in 2001 [1]. Different methods to block the ingress of water in the central tube have been introduced, but all designs rely on a super absorbent polymer filling compound as a replacement for gel in the central tube as shown in Figure 1.

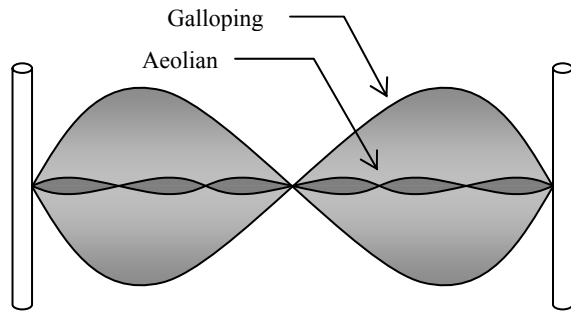
Figure 2. Cable Vibration Conditions

An aerial cable may undergo two main categories of vibration, galloping and aeolian. The categories are separated by their frequency and amplitude. Galloping vibration is described by its high amplitude and low frequency. Aeolian vibration has a high frequency and very low amplitude, approximately half the cable's diameter. An illustration of these two types of vibration is shown in Figure 2. Lashed aerial cable may gallop with the proper conditions so it is important to test this specific condition. The conditions of aeolian vibration are rare in nature in lashed aerial cable installations. The multi-degree of freedom systems typically have too much damping to allow a resonance in the span with amplitude equal to half the cable diameter to exist. While lashed aerial cable is unlikely to resonate at frequencies required for aeolian vibration, it may simulate environmental vibration from sources such as railway beds or auto traffic on a bridge or slope.

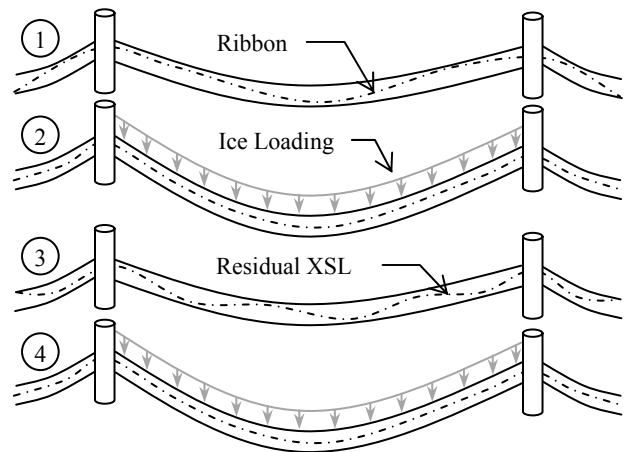
Figure 3. Ice Loading Conditions

Under ice loading conditions cable will elongate. If the cable elongation exceeds the cable's intrinsic excess ribbon length, ribbon will be pulled in from an adjacent cable section as shown in Figure 3, Items 1 and 2. If the cable elongation resulting from the load event exceeds the intrinsic ribbon excess length of all adjacent spans, ribbon may be pulled tight against slack loops or closures if slack loops are not present. This condition exists for both gel and dry cables.

As the ice load is released, the ribbon pulled in from adjacent cable sections creates a new permanent excess ribbon length in the cable, as shown in Figure 3, Item 3. During the next ice loading event the cable will elongate, but since ribbon excess length equal to the strained cable length is already present, no further ribbon will be "pulled" into the section, as shown in Figure 3, Item 4. The cable has essentially reached a new equilibrium.

Once this process is understood, the analysis of the magnitude of the cable elongation, induced ribbon excess length, and robustness of the cable design may be analyzed. Performing the catenary calculations for these scenarios on a "worst case" lashed aerial cable and span length the cable elongation achieved was less than 0.05% for NESC Heavy ice loading conditions [8]. With this knowledge it is imperative to ensure that the cable design is capable of accommodating this amount of ribbon excess length with neither attenuation loss nor imparting damage to the fibers. The intrinsic ribbon excess length value is designed to exceed this cable elongation.

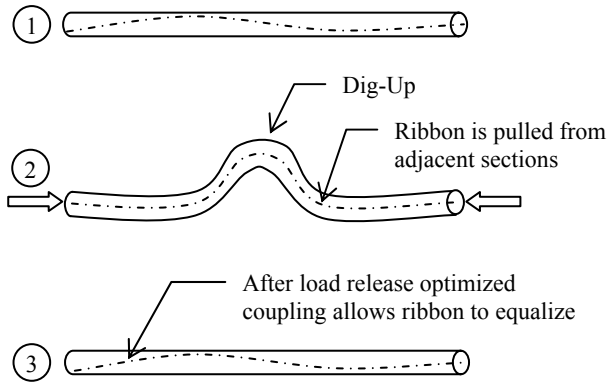
**Figure 4. Dig-Up Strain Event**

The question has been posed as to the effect of direct exposure to the high strain on the adjacent cable sections. Estimation of a 50m cable section exposed to a strain, with a load that is near the breaking strength of most cable designs, results in ribbon pulling in from the adjacent sections and may indeed pull tight against slack loops in both dry and gel filled cable. The ability of the cable and ribbon to absorb this strain depends on the cable design, the intrinsic excess ribbon length, and the length of the adjacent section of cable. Whatever coupling is present will either prevent or allow the ribbon strain from transmitting down the cable length and prevent or allow the cable to equilibrate after release of the load. Figure 4 illustrates this event.

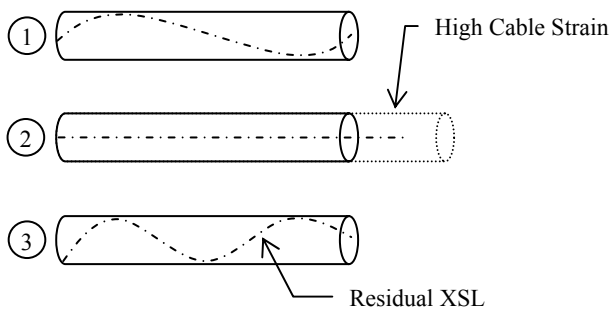
**Figure 5. Installation Strain Event**

**2.2.3 Installation.** During installation a localized section of cable is subjected to a large strain. It has been reported with some cable designs that this will cause the ribbons to remain stationary while the cable is pulled over them, as shown in Figure 5. When the load is released there is no tensile force on the ribbons at the exposed end, so some length of ribbon remains within the cable. An installer is likely to be alarmed to see no ribbons exposed at the end of the cable after the cable pulling is complete!

This specific end condition also exists for some gel filled designs when subjected to certain installation conditions. The solution is to remove a small section of cable jacket, usually less than 1m, to recover the ribbons. The question again returns to what effect does this condition have on the cable section as a whole?

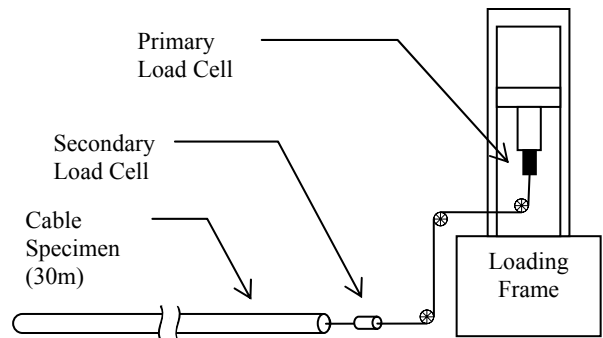
**Figure 6. Ribbon Coupling Testing Apparatus**

For some cables, especially with lower fiber counts, questions have been proposed about the interaction of the test apparatus given the inherent friction of the pulleys involved. A solution was proposed that elevated the cable sample from the ground to a tray to attempt to eliminate at least one pulley. We propose another solution that introduces a second load cell, located directly in-line with the cable sample. The loading frame load cell is still monitored and the frame controls the rate of movement fixed by the method at  $100 \pm 25$ mm per minute, but the absolute load is given by this in-line secondary load cell. This apparatus is shown in Figure 6.

The update to the small scale cable testing apparatus helped ensure more accurate results for coupling force. It then became necessary to construct a test that could create a high strain event.

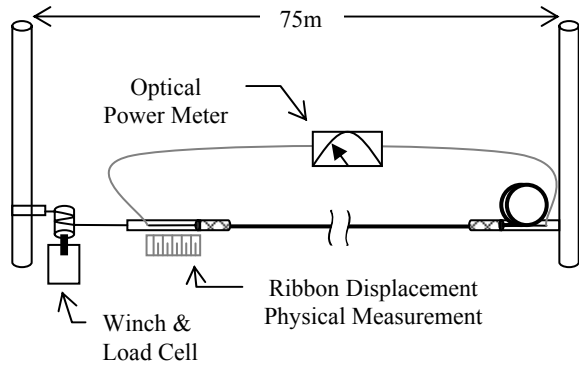
**Figure 7. Cable Strain Event Apparatus**

Using an electric winch and load cell, a cable was strained between two anchored poles 75m apart. By carefully gripping the cable, the ribbons were exposed at both ends and spliced to an optical power meter operating at 1550nm. The ribbons were also placed in such a way as to allow physical linear movement to be measured on one end while the other end was put into slack loops to simulate field conditions. The cable strain event apparatus is shown in Figure 7.

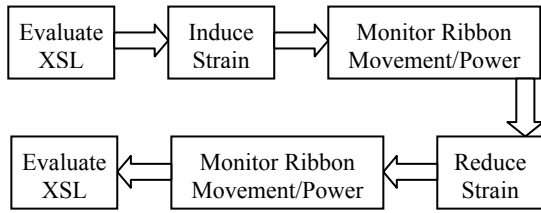
**Figure 8. Ribbon Strain Event Testing Procedure**

Prior to beginning and upon completion of the cable strain event test the cable sample is tested for ribbon excess length (XSL) to remove the possibility of excessive ribbon to cable length differences skewing the results. The cable sample then proceeds through the remaining testing procedure described in Figure 8.

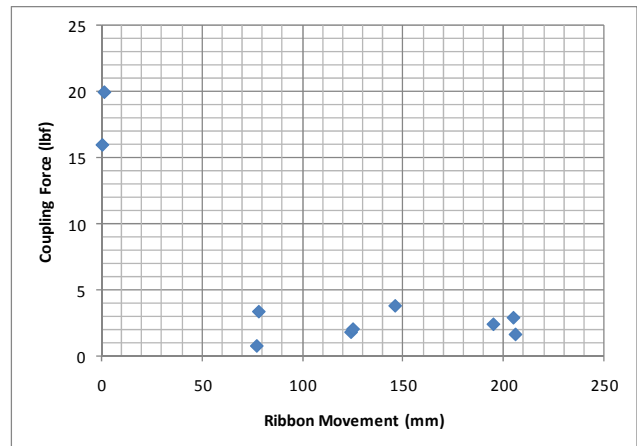
**Figure 9. Ribbon Movement vs. Coupling Force**

To validate the correlation between coupling force and ribbon movement, the coupling force measured using the loading frame event apparatus was compared to the ribbon movement observed using the strain event apparatus.

Figure 9 demonstrates that above a threshold of coupling force, ribbon movement is certainly retarded. Below this threshold the coupling force is not a good indicator of ribbon movement.

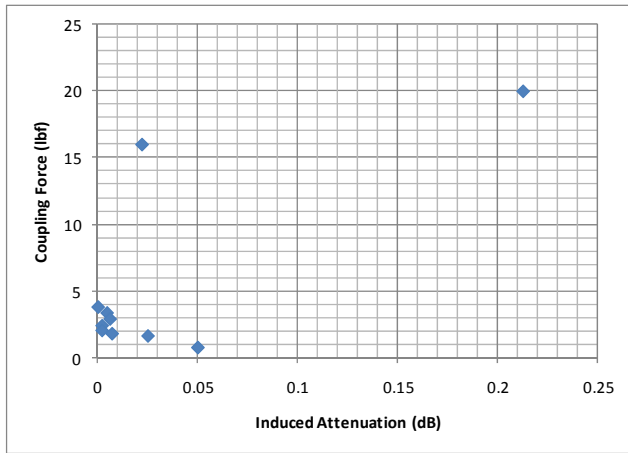
**Figure 10. Induced Attenuation at Release vs. Coupling Force**

The next relationship of interest was the amount of attenuation change induced after a load release from a high strain event versus the coupling force from the loading frame apparatus.

Figure 10 demonstrates that at very high coupling resulting in only a few millimeters of ribbon movement a large attenuation increase is possible. The high coupling does not allow the ribbons to redistribute or relax.

The one data point illustrating this phenomenon does not indicate that this is always the case. More testing at this coupling level would be necessary to better define the amount of coupling and exact circumstances that would cause this issue. This particular event occurred with a 48 fiber count cable comprised of four 12 fiber ribbons. Unlike gel filled cables, dry central tube ribbon cables do not have means to keep the ribbons in a uniform stack. The dependence on a uniform ribbon stack for antibuckling is suspect and this condition may also present itself for higher fiber count cables as well.

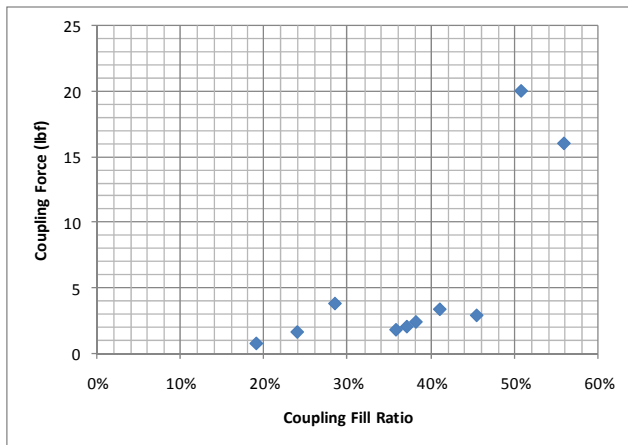
**Figure 11. Coupling Fill Ratio vs. Coupling Force**

Figure 11 shows that at approximately 50% coupling fill ratio the water blocking elements begin to compress and impart significantly higher coupling force. This indicates that there is a threshold below which this parameter does not correlate with coupling force. For this cable design a linear relationship of coupling force does not exist.

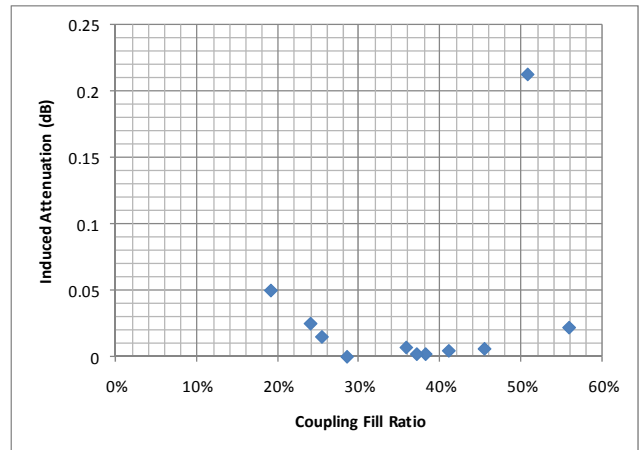
**Figure 12. Coupling Fill Ratio vs. Induced Attenuation**

Finally, Figure 12 demonstrates the need to set the coupling fill ratio parameter below 50%. All attenuation results below this level are 0.05dB or less.
