Application of Retrofit XLPE Cable for Existing Circuit

A large number of high-pressure fluid-filled (HPFF) and high-pressure gas-filled (HPGF) pipe-type cables had formerly been installed in U.S. power transmission lines since 1930s. As the pipe-type cables age, corrosion of the steel pipes and leakage of the dielectric fluid have become a problem. Using technology patented in the U.S. and Japan, Sumitomo Electric Industries, Ltd. designed, delivered, and installed its new high-voltage cross-linked polyethylene (XLPE) triplex cable and its accessories for the existing transmission lines.

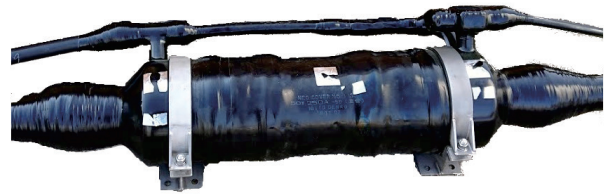
Photo 2. Joint

In general, a power cable system is formed by connecting cables using joints in manholes (see Photo 2).

Our cable is characterized by a triplex structure, which helped reduce the axial force and cable expansion toward the conduits. It does not require an offset, making it possible to reduce the manhole size. It is provided with a support for grounding and securing an aluminum pipe.

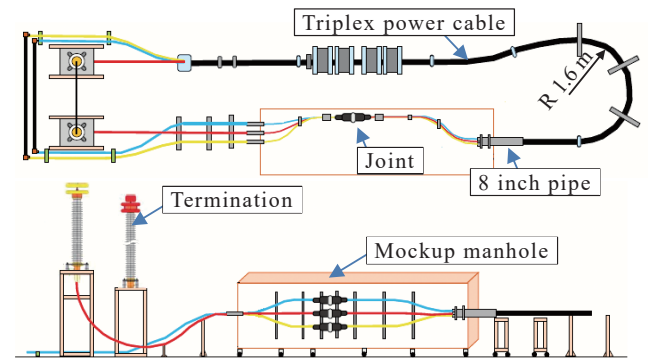
Fig. 5. Configuration of Type test circuit

A type test was conducted in accordance with AEIC CS9-15 (Table 4) as a demonstration test. Figure 5 shows the configuration of the verification system. An eight-inch steel pipe was installed for the line. Joints were installed in a mockup manhole, whose size was the same as that of the existing manhole, and outdoor terminations were installed on both ends of the line.

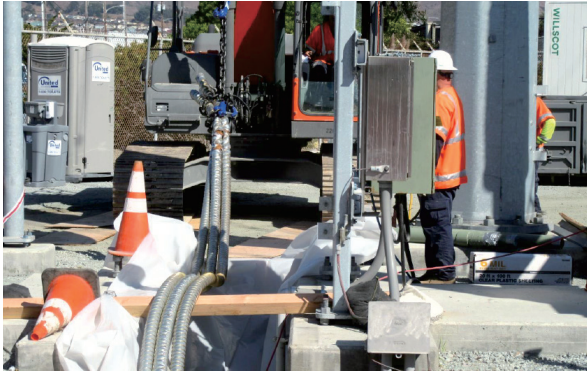
Photo 3. Removal of existing cable

All existing HPGF cables were removed (Photo 3), and the space inside the pipes was cleaned. A test piece was introduced into the pipes to verify the installability of the new cable. Smart Pig*⁵ was used to investigate the deterioration status of the pipes. It was confirmed that the cable could be installed properly.

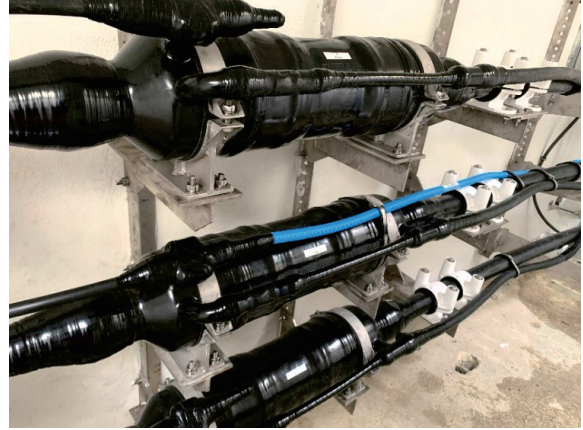
Photo 6. Assembled Joint

The design and materials of the joint support were certified under the Professional Engineering Stamp*⁶ of the U.S. The joints were assembled in the manhole. The completed status is shown in Photo 6.

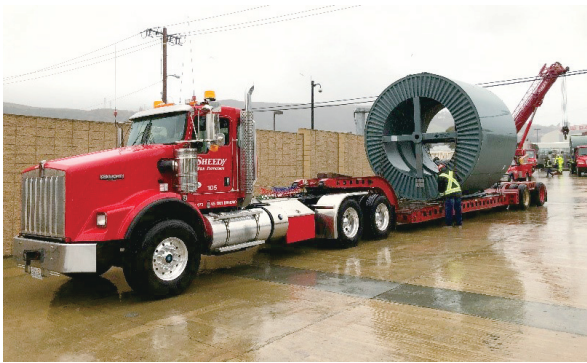
Photo 4. Transport of the cable

The power cable was coiled around a large drum (4.2 m in diameter × 3.5 m in width). A route that did not interfere with overhead power lines was chosen on site. The drum was transported to the construction site at night (Photo 4).

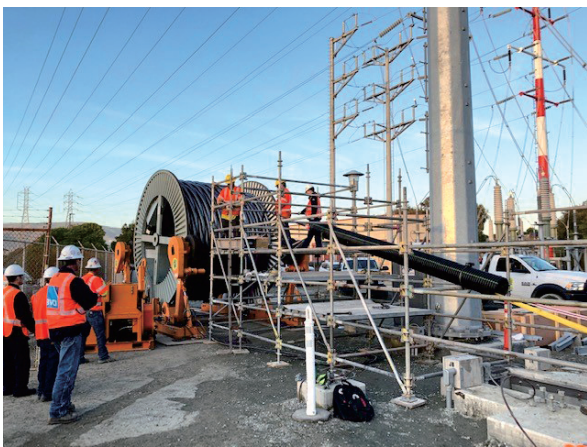
Photo 5. Cable installation

the termination to the manhole. The site was adjacent to aerial lines, other feeders, and buildings. The pass line for installation was arranged by examining the drum layout and transfer method (Photo 5). A cable test piece 5 m long was introduced into a pipe on a trial basis. This cable was confirmed to be installed properly. Subsequently, a new cable was installed.

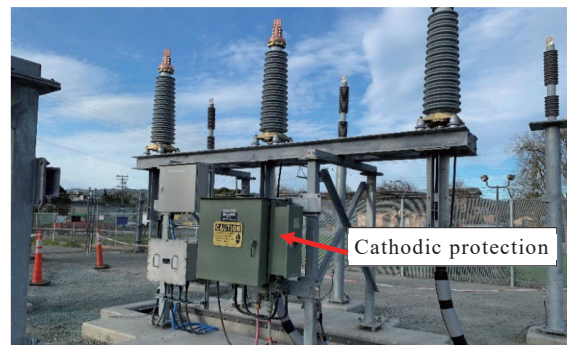
Photo 7. Assembled termination

An open pit was provided under the trestle of outdoor termination. The triplex cable was branched without using a riser pipe to construct the terminations. Photo 7 shows the completed status. The existing line was equipped with cathodic protection (CP) to prevent corrosion of the steel pipes. The system was designed so that CP would work after the replacement and the steel pipes can be effectively utilized in the event of cable replacement in the future.

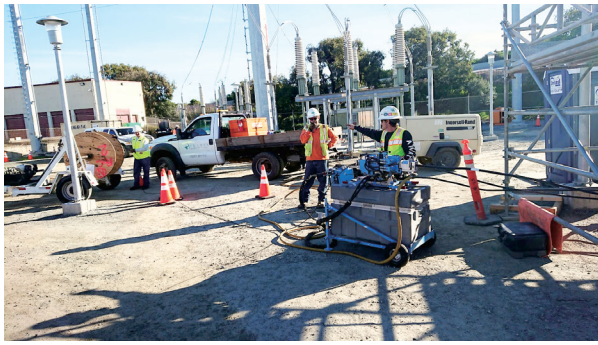
Photo 8. Installation of Optic cable

After installation of the triplex cable, air blown equipment was used to introduce an optical cable into the aluminum pipe (Photo 8).

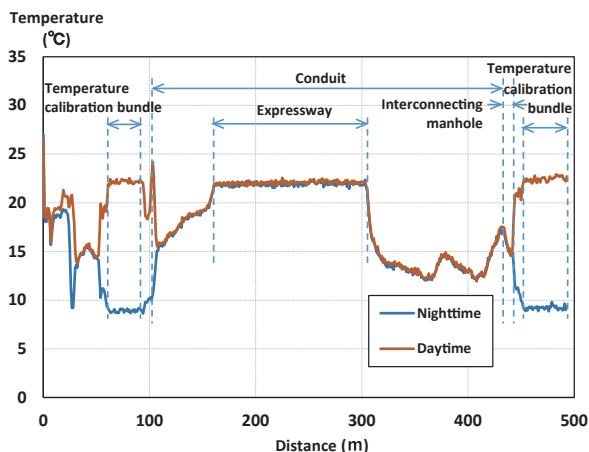
Fig. 6. Temperature distribution graph

The temperature distribution graph of OPTHERMO is shown in Fig. 6. The route of the optical cable was from the substation control room to the cable end (near end), cable section, interconnecting manhole, and cable end (far end). An optical cable bundle for temperature calibration was set up at the cable end. The temperature distribution in the figure shows a superimposition of the daytime and nighttime graphs. It shows that the temperature at the buried location does not change but that the temperature of the temperature calibration bundle in the air does. The temperature under the expressway is high due to the presence of asphalt. There were no singular points (hot spots) along the route that raised concern.

With the start of operation of the cable, the soil temperature would gradually increase due to heat generation by energization. Comparison between temperature

distributions before and after energization helps detect singular points of temperature increase and the formulation of measures, such as improvement of the soil environment and control of the energization current.

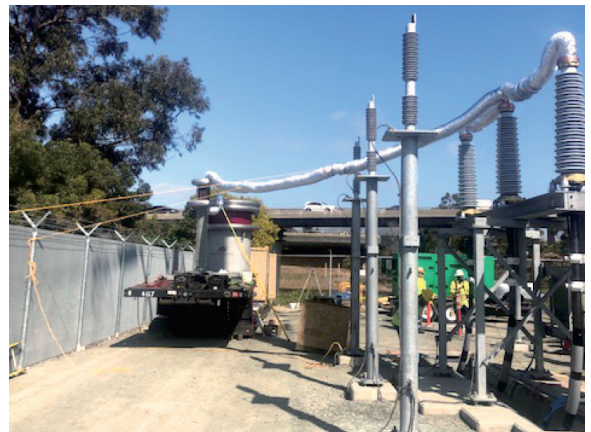
Photo 9. Commissioning test

After installation of the cable and assembly of all the components, an anticorrosion withstand voltage test, an AC withstand voltage test ($1.7 U_0$: 113 kV \times 1 hour), and partial discharge measurement ($0.8 U_0$: 54 kV, $1.0 U_0$: 67 kV, $1.7 U_0$: 113 kV) were conducted for the power cable system. For the DTS, an optical loss measurement test and an operation check test were conducted. Commissioning test was completed satisfactory on March 15, 2020. The status of commissioning test is shown in Photo 9.
